In flight Upset Accident Review: Lessons for Training

Dennis A. Crider

Chief Technical Advisor, Vehicle Simulation
National Transportation Safety Board

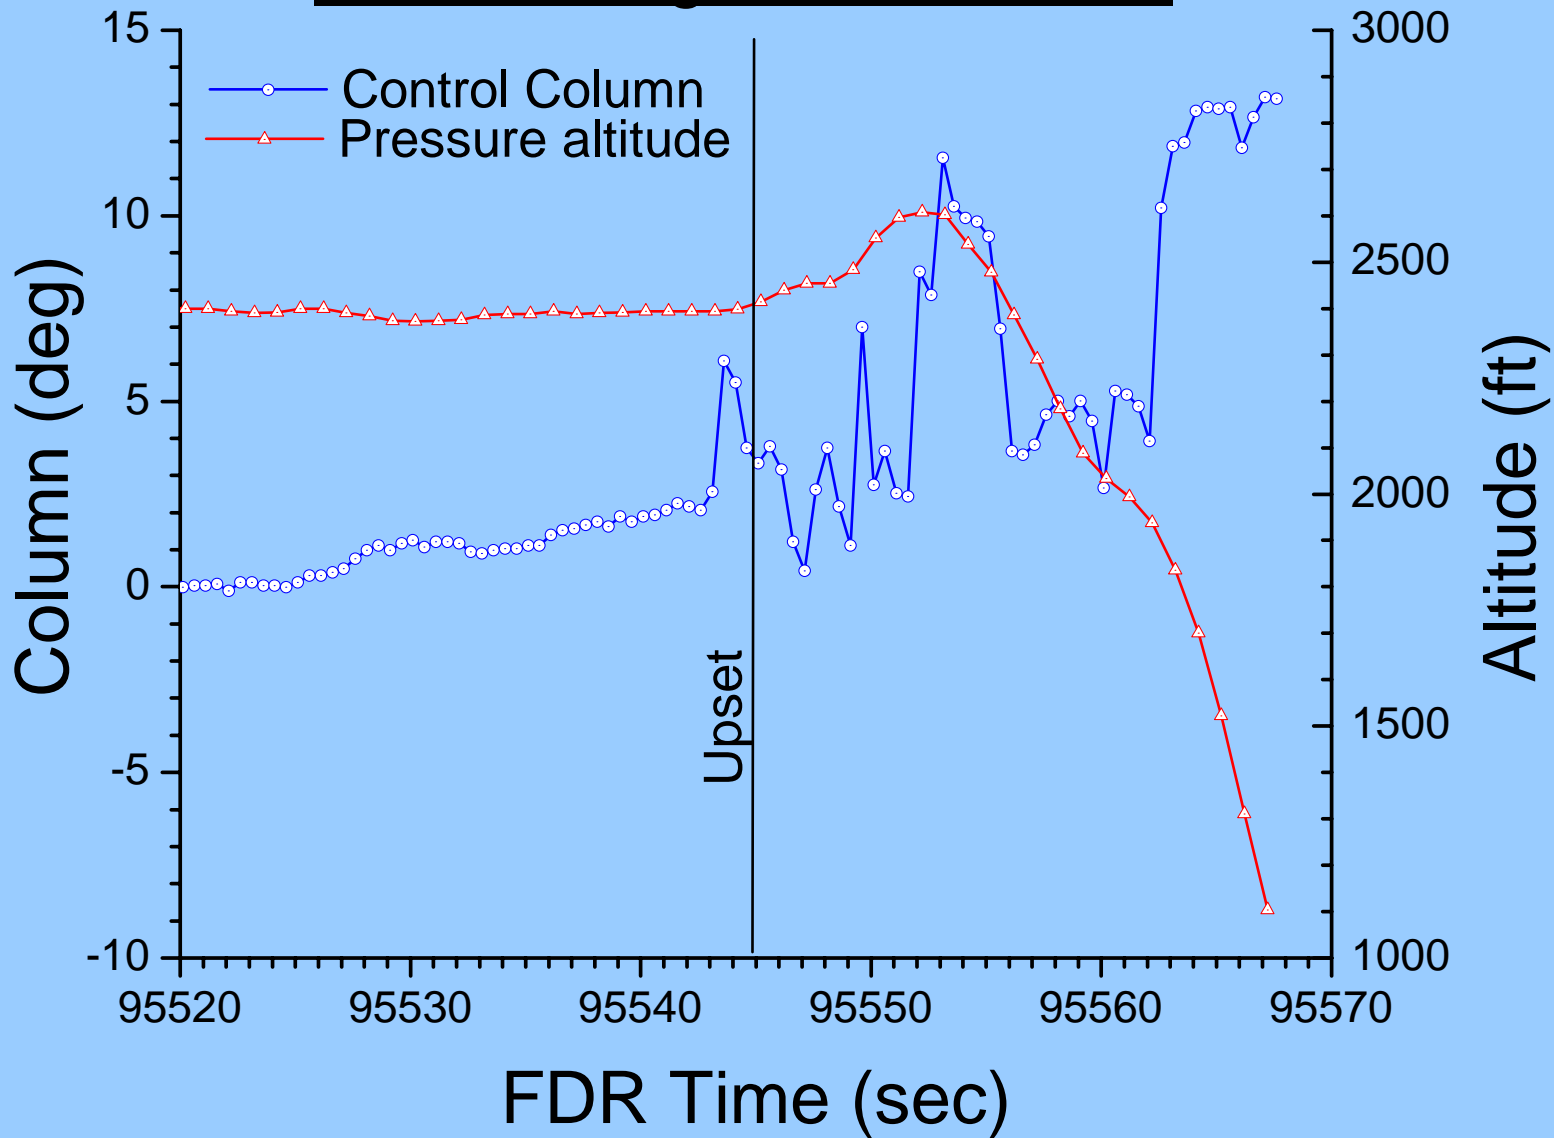
Buffalo Colgan DHC-8-400

- **Continental Connection Flight 3407
Bombardier DHC-8-400, February 12, 2009**
 - While on approach to Buffalo the aircraft slowed after a power reduction to the point stick shaker activated
 - at a reduced angle of attack due to being set for icing conditions.
 - The pilot pulled back in response to the stick shaker and stalled.
 - The pilot fought the stick shaker and failed to recognize the rolling with ineffective roll controls as an indication of stall.
 - Controls remained aft till ground impact.

The National Transportation Safety Board determines that the probable cause of this accident was the captain's inappropriate response to the activation of the stick shaker, which led to an aerodynamic stall from which the airplane did not recover.

Contributing to the accident were (1) the flight crew's failure to monitor airspeed in relation to the rising position of the low-speed cue, (2) the flight crew's failure to adhere to sterile cockpit procedures, (3) the captain's failure to effectively manage the flight, and (4) Colgan Air's inadequate procedures for airspeed selection and management during approaches in icing conditions.

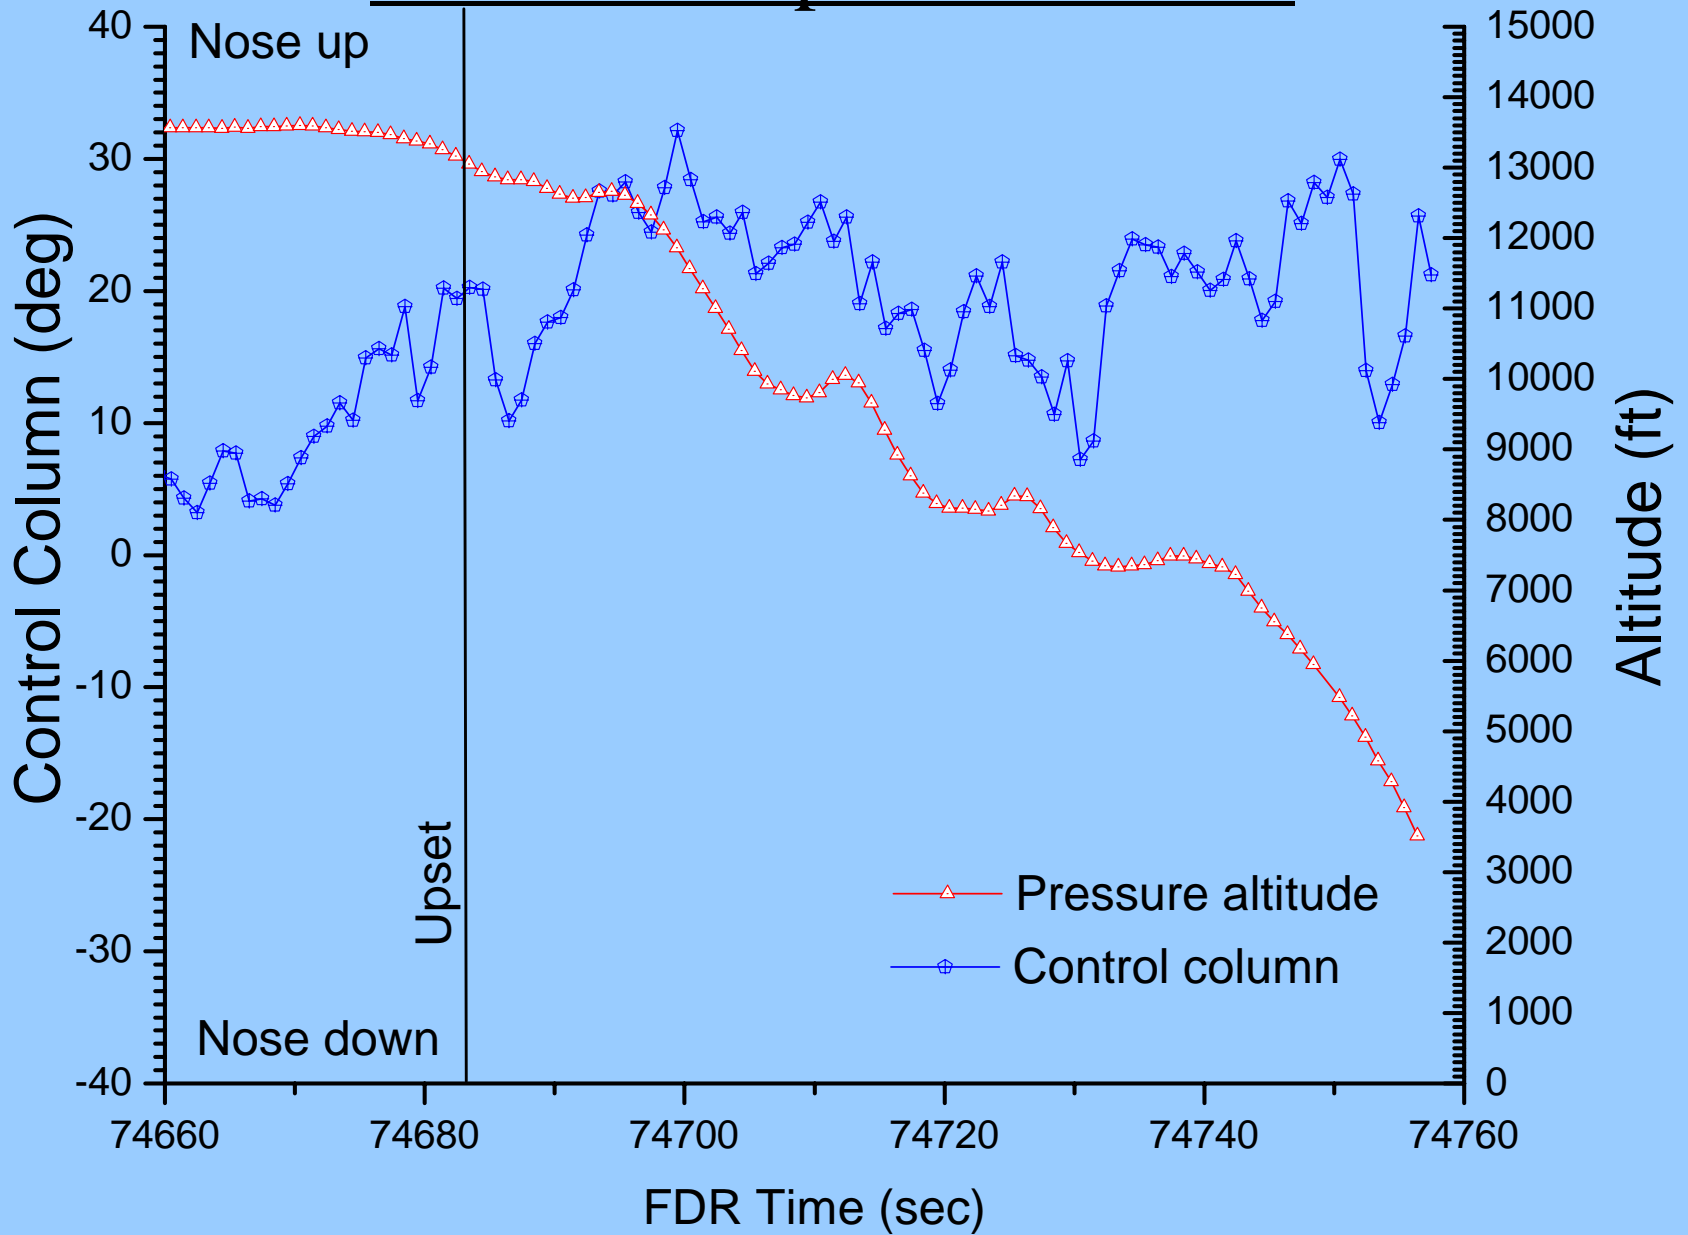
Airborne Express DC-8-63

- **Airborne Express DC-8-63 December 22, 1996**
 - As part of a functional evaluation flight-following modifications and a “C” check, the crew was conducting a stall speed test a 13,600 feet when the aircraft stalled without the stick shaker. The crew increased power but maintained aft column throughout the departure. The aircraft did not recover from the stall but experienced a series of roll oscillations at a nose-low attitude for most of the descent until ground impact. The crew had trained in a simulator that produced a stall upset without roll excursions and in a nose-high attitude counter to the nose-low roll oscillations that the crew actually experienced.

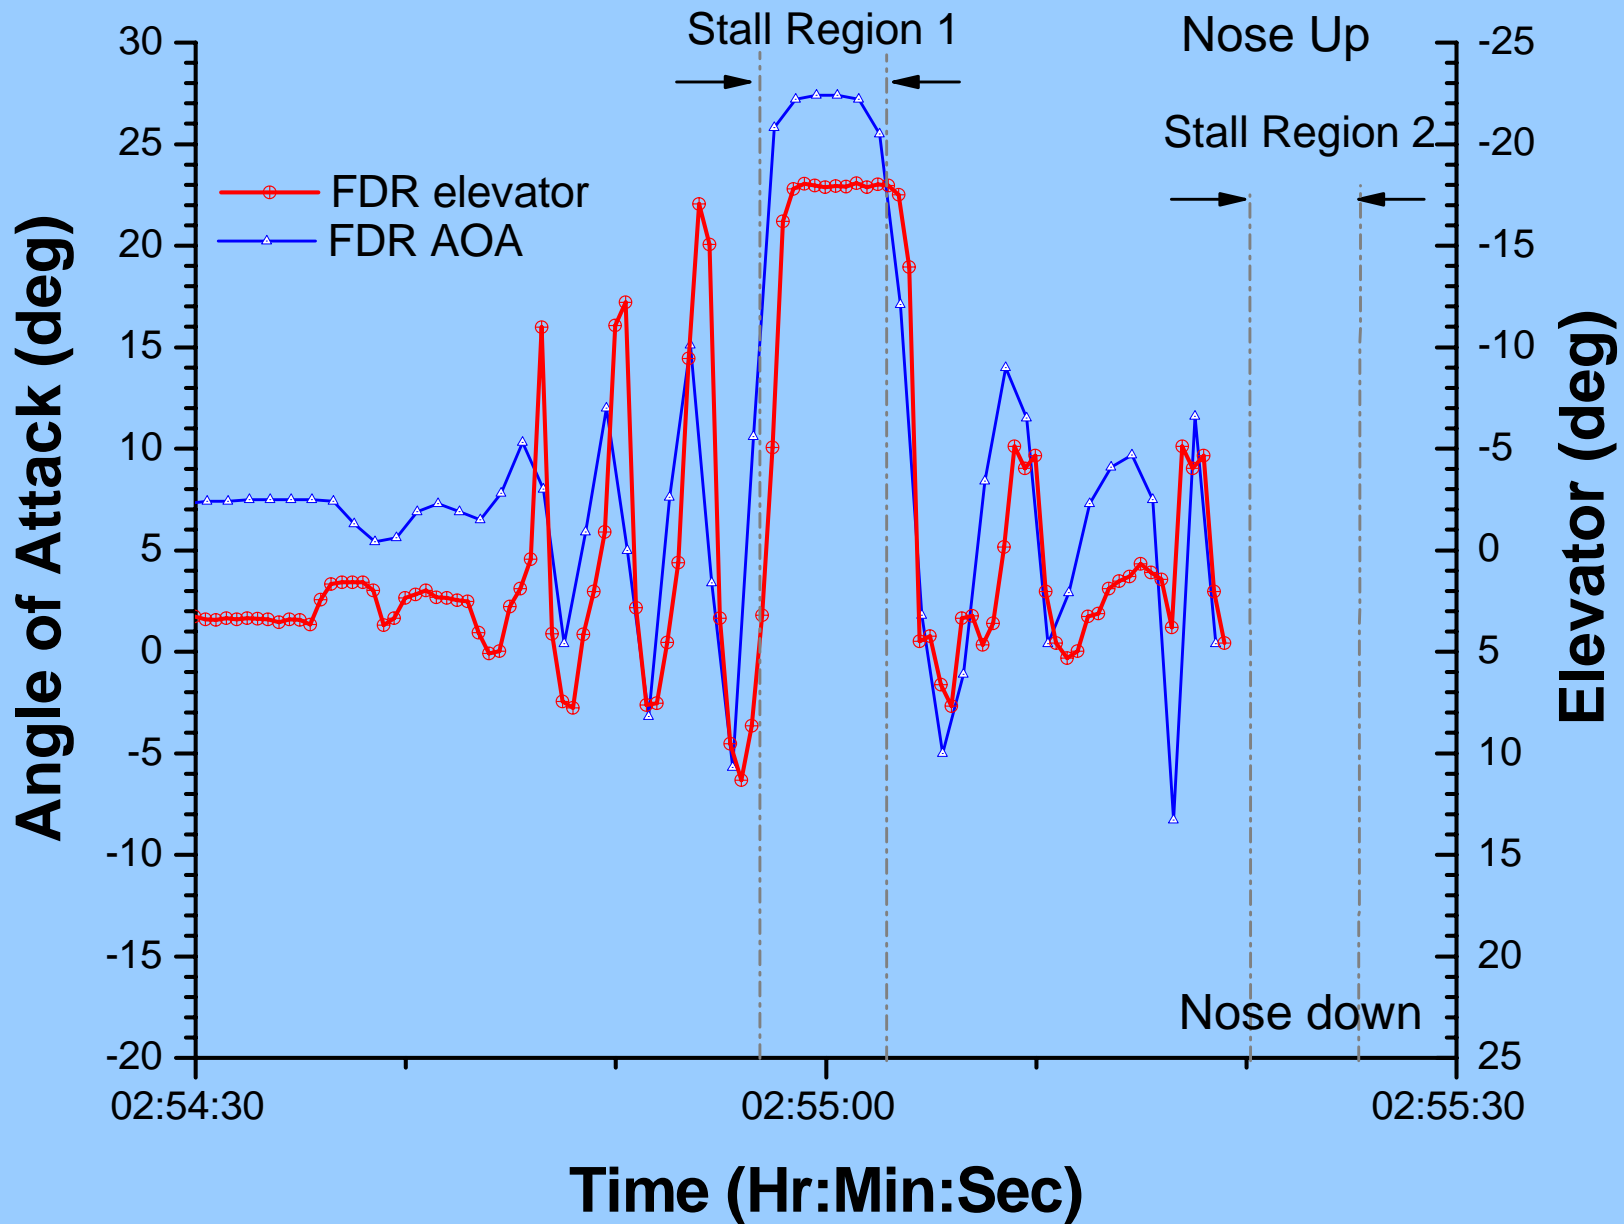
Pinnacle Airlines Flight 3701

- The aircraft was on a repositioning flight when the crew decided to climb to the performance limits and set the autopilot for a climb rate. As the aircraft climbed to 41,000 feet, the aircraft slowed and stalled causing both engines to flame out. The aircraft rolled to 80 degrees left with the nose 25 degrees nose-low while the crew maintained up elevator ignoring the shaker and fighting the pusher. The crew stalled a second time after recovering from the first stall when they tried to re-establish normal flight attitude too quickly. The crew had never had a simulator exercise to demonstrate the stick pusher.

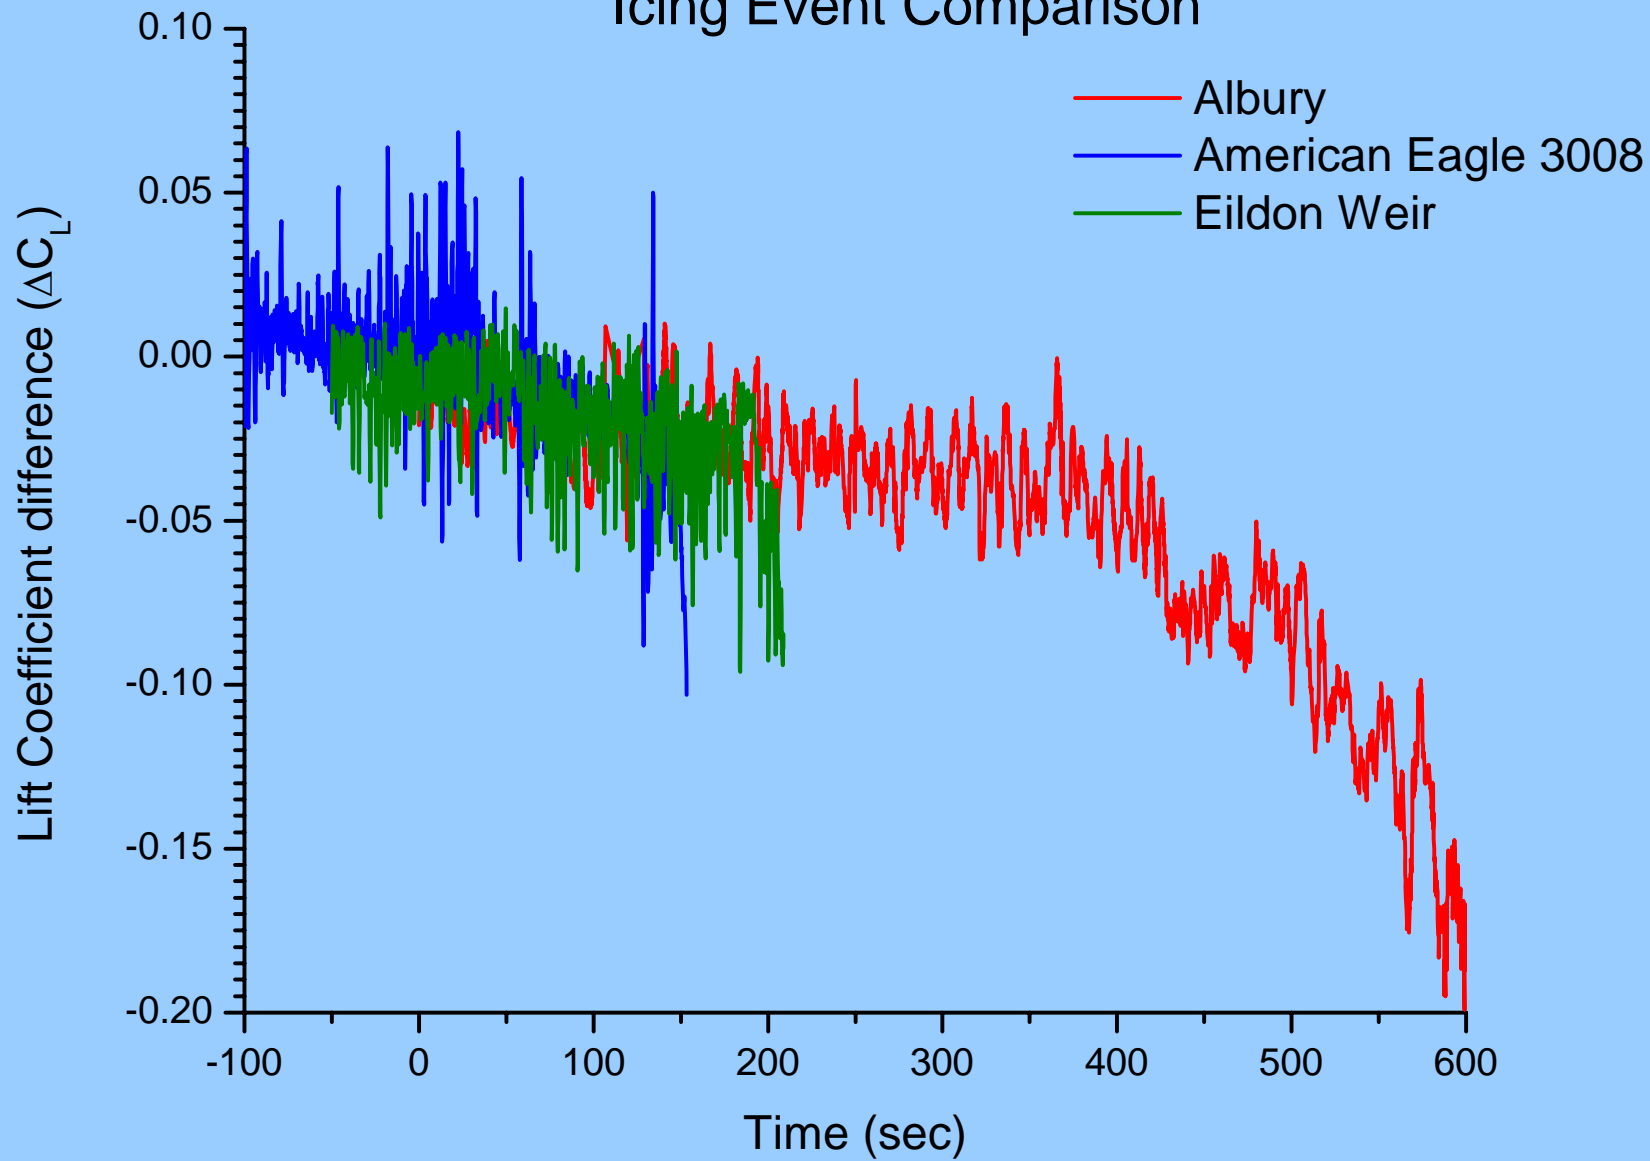
Saab 340 Icing Event Comparison

- Saab 340: Eildon Weir, Australia,
 - November 1998
 - 2300-foot altitude loss
- Saab 340: Albury, Australia,
 - June 2004
 - 40-foot altitude loss
- Saab 340: San Luis Obispo, CA, USA
 - January 2006
 - 5000-foot altitude loss
